One of the things that gives Ansty Village a real sense of identity are its stone cottages and stone walls.

## Ansty Village Stone Walls 2

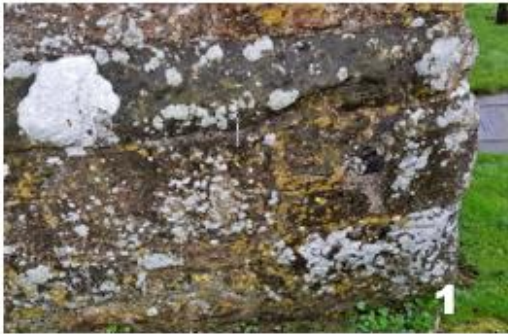
1 Greensand plinth at foot of southern gable end of the Commandery building built at the end of 16<sup>th</sup> century. 2 & 3 Capped and uncapped greensand stone wall near St James' Church. 4 A wall beneath the Ansty Public Noticeboard – note the different style of capping. 5 Another long run of greensand walling below Lower Farm, looking west towards 12 Acre Copse. This wall displays different styles of capping. Part of it was damaged in recent years but nicely repaired. 6 A low-walled paddock opposite the noticeboard. Note the odd irregular block of greensand stone marking the verge. 7 & 8 Better dressed blocks enable the walls to be built with considerable durability. You can sometimes see Tisbury Stone and other rubble stone inserted in random places possibly as a repair at some stage.
